CURRENT RESEARCH INTO THE REDUCTION OF THE NUMBER OF TRANSMISSION LINE FAULTS ON THE ESKOM MTS

F.F. BOLOGNA, A.C. BRITTEN and H.F. VOSLOO

TSI-Eskom Enterprises, Transmission Group, Eskom

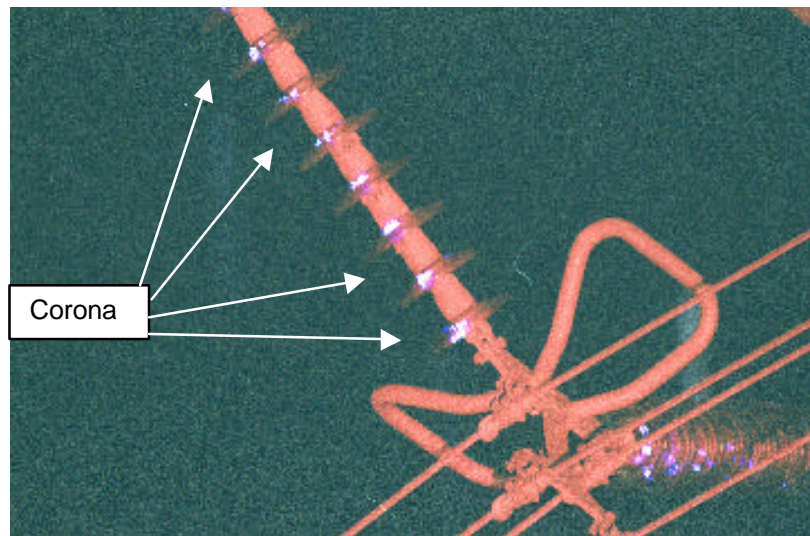
Figure 3

During periods of high humidity unusual corona glow is observed on the top surface of many of the insulator discs. This has been observed to occur from the live end to the earth of a string (Figure3).

Unusual Corona Activity photographed on the Grassridge-Poseidon 400kV Line

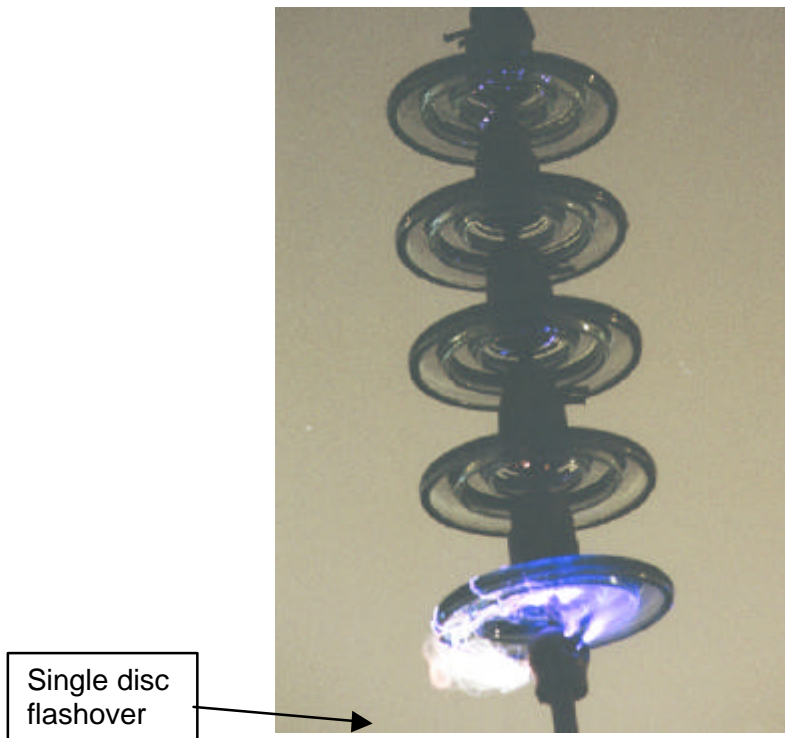
On the other hand, laboratory component of this work has shown that a wetted, light pollution layer can create sparking on an insulator surface, and in cases where the disc is dry, a flashover across that disc. Figure 4 shows a single disc flashover under laboratory conditions.

An example of single disc flashover.

Although this work has given encouraging results, a flashover across an entire string has not yet been demonstrated. In order to reduce the effect of sparking, recommendations have been made that larger insulator discs (disc having a higher flashover voltage) be added to existing strings. This has been proposed and implemented on parts of the Grassridge-Poseidon 400 kV line. Future research in this area will focus on single disc flashover as the initiating mechanism.
