Brittle Fractures of Composite Insulators an Investigation of their Occurrence and Failure Mechanisms and a Risk Assessment

by
Frank Schmuck and C. de Turreil
for
CIGRE WG 22-03

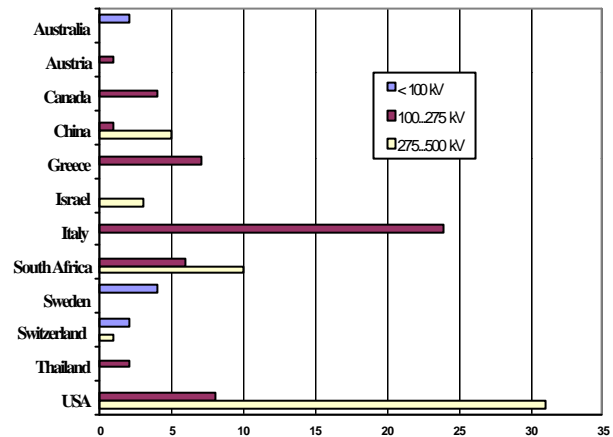
Fig. 2-1: Number of brittle fractures on lines [1, 2]

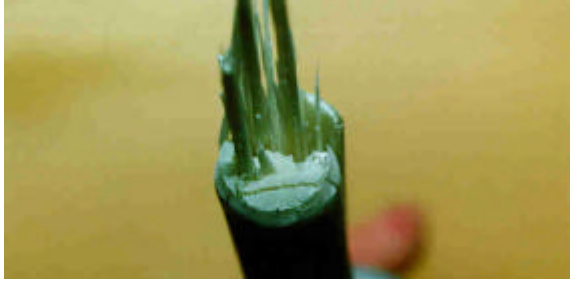
laboratory test is shown in Figure 4-1 [10]. On the front side of the fractured area, the smooth surface has failed by the stress corrosion process; the tension load was transferred to the remaining fibres that broke instantaneously when the specific strength was exceeded. More details regarding the identification of brittle fractures are found in [3].

Fig. 4-1 : Failure pattern of a brittle fracture

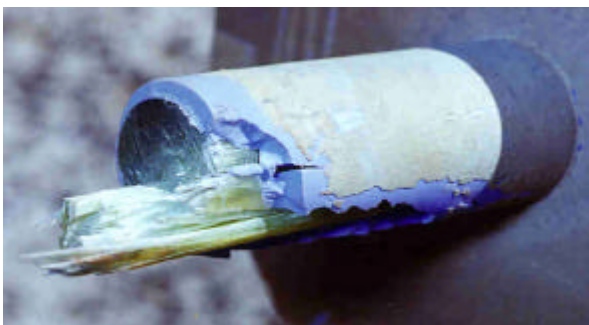
- failures without visual damage of seal,
- fracture located at a certain distance from the end fitting or within the end fitting, where low electrical field are expected (Figure 4.2-1),

Fig.4.2-1 : Brittle fracture about 1 cm inside the end fitting.

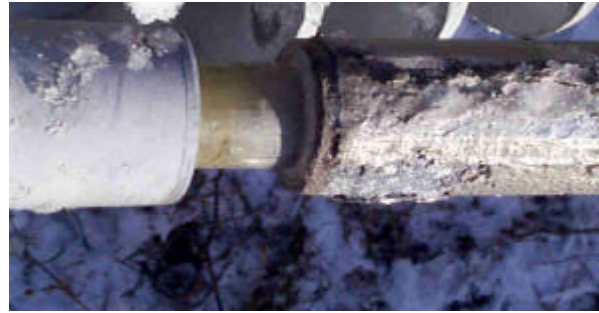
- in service, the number of brittle fractures is smaller than the number of insulators with exposed rods (Figure 4.2-2),
- among insulators from the same batch, installed on the same line, one can fail and the others provide trouble-free service.

Fig. 4.2-2 : no damage after more than 10 years in service with an exposed FRP rod.

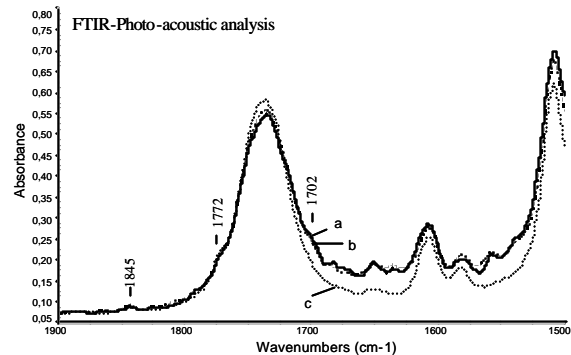
Fig. 4.2-3 : IR spectra of area a, b and c of the FRP rod.

The curves relate to different rod areas, "a" and "b" correspond to the fracture face and "c" to the unaffected bulk of the rod. The peaks at 1845 cm⁻¹ and 1772 cm⁻¹ found on all three curves correspond to unreacted hardener. The small increase for curves "a" and "b" at 1702 cm⁻¹ is associated with the acid formed from the hardener. This increase was not found for curve "c" (inside the rod, no contact with water). A visual inspection of the insulator indicated a faulty seal between the polymeric housing and the end fitting, which led to the ingress of moisture followed by acid creation. Probably due to the small load and the progressive loss of sealing integrity the insulator took 15 years to fail.

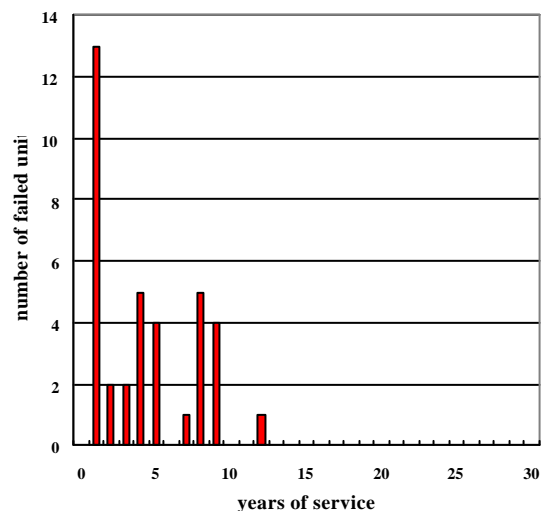
Fig. 6-1 : Brittle fractures in USA

Figure 6-1 shows the distribution of brittle fractures reported in the world with different insulator designs. More brittle fractures

- in-service inspection of composite insulators to detect possible polymeric housing damage caused by frequent electrical discharge activity,
- specification of a sheath thickness of at least 3 mm,
- prevention of corona on hardware of the insulator at nominal voltage,
- visual control of the seals or the bonding between housing and end fitting,
- removal from service of insulators with exposed rod.

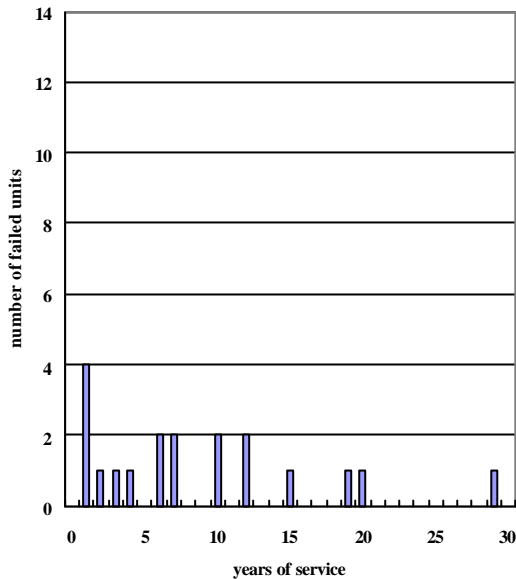
Fig. 6-2 : Brittle fractures of one type of insulator in various applications and different environmental conditions.

may still appear with time. Figure 6-2 reports on the behaviour of one insulator family (1st generation) the manufacture of which has been discontinued in 1983.
