OUTAGES OF THE BRAND-SE-BAAI 132kV FEEDER –  
THE INSULATOR PROBLEM THAT WASN'T

R E Macey and W L Vosloo\*

Mace Electrical Technologies  
P O Box 739, Lonchill, 2062

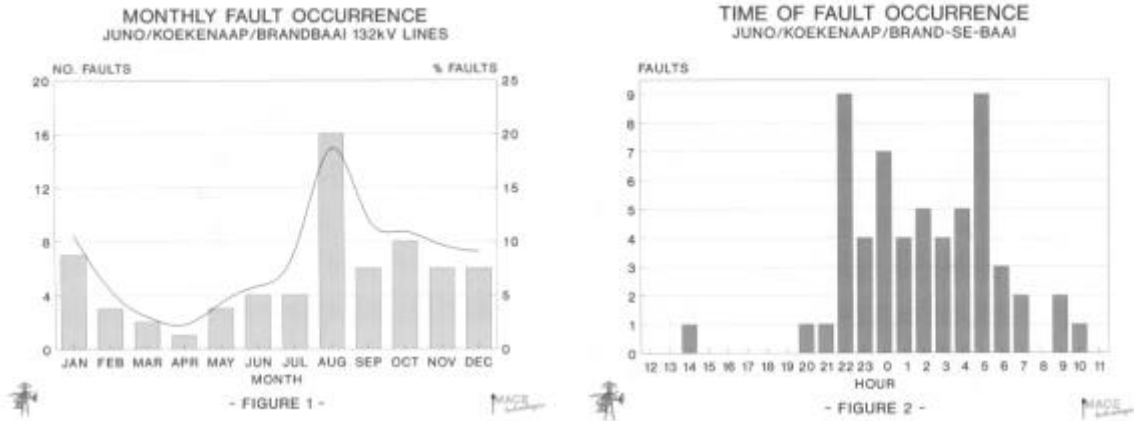
The occurrence of faults in relation to the time of year is shown in Figure 1. It is evident that the faults peak in spring, remain fairly high during the summer and are far less frequent in winter. For pollution flashovers, one would expect a peak in autumn when the first fogs and drizzle of the winter occur after the long, dry summer.

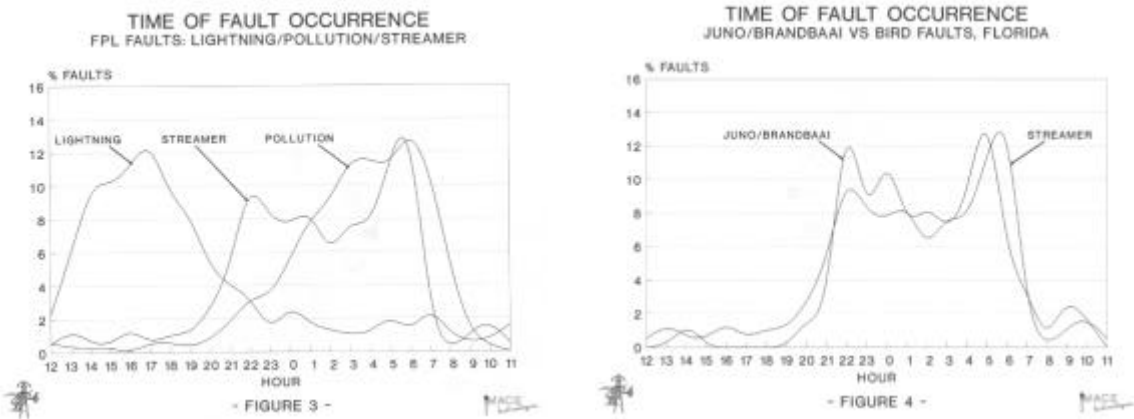
The time of day of the fault occurrences are plotted in Figure 2. It can be noted that approximately 90% of the outages occur at night with definite peaks apparent at 10pm and 5am. Pollution flashovers are expected in the early hours of the morning but are not at all common in the late evening.

From comprehensive analyses of faults undertaken on the Florida Power & Light system [1], time-of-day fault patterns have been established for lightning, insulator pollution and bird streamer outages. These are illustrated in Figure 3. In Figure 4, the bird streamer curve is compared to the trip occurrence curve of the Brand-se-Baai feeder. The Florida data is based on 201 faults on 138kV and 230kV wooden H-pole structures so is well representative of the local situation. The similarity of the two profiles is marked.
