The design and evaluation of a Multi-Spectral Imaging Camera for the inspection of transmission lines and substation equipment

By R Stolper and Jaco Hart, CSIR and N Mahatho, Eskom, South Africa

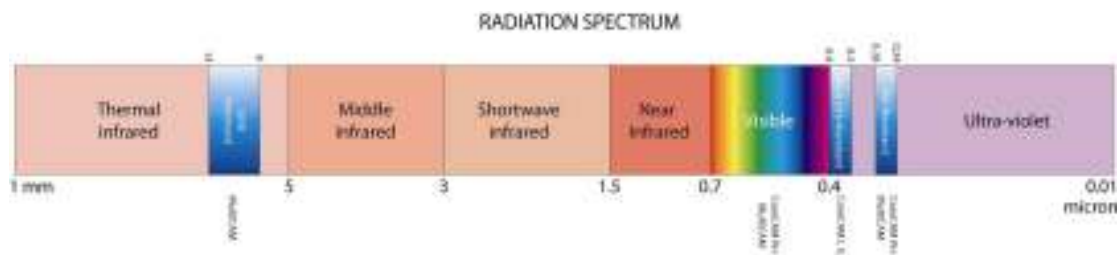
Figure1: Electromagnetic spectrum used in multi-spectral imager

The wavelengths of the electromagnetic spectrum are divided into different categories, named after its application, such as the x-ray domain for short wavelengths with powerful penetrable photons, the visible spectrum where human beings can observe objects and the long length radio waves where communication waves are transmitted and received. The multi-spectral imager explores the ultraviolet wavelengths between 200nm to 280nm, the visible wavelengths of 400nm (dark blue) to 780nm (red) and the heat wave lengths of 8 μ m to 12 μ m, as illustrated in figure 1.

A current flowing through a high resistance caused by a poor electrical contact between two surfaces results in an electrical I^2R loss appearing in the form of heat. The temperature range for a hot connection varies according to the load and resistance and may be anywhere between 10°C above the ambient temperature to approximately 100°C and above. The greater the load on the network, the greater is the I^2R effect which can eventually lead to burnt connections and damage, and even possibly power outages. It is therefore important to scan the electrical network on a regular basis for hot spots. Electrical hot spots radiate energy in the so called long wavelength infrared spectrum, depicted as LWIR in Figure 1.

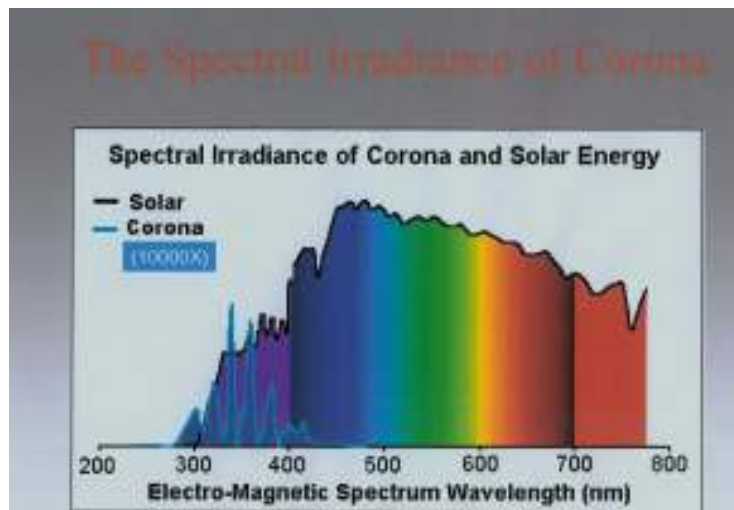
Figure 2: Spectral irradiances of corona

Corona activities on electrical equipment radiate energy in the form of light, mainly in the ultraviolet band of the electromagnetic spectrum 300-400nm [4] (spectral peaks at 340 and 360nm). However, a small portion of the corona energy radiates below 280nm in the so called solar blind spectrum. In this part of the electro-magnetic spectrum, below 280nm and onwards, no solar radiation reaches the earth surface due to the ozone layer around the earth sphere which acts as filter and blocks all ultraviolet C and soft x rays. Under normal conditions objects are seen due to reflected light that is projected on a sensor. But in case of the solar blind spectrum only active radiation sources are seen, no reflection patterns such as contours are seen. The irradiance characteristics of corona are shown in Figure 2.

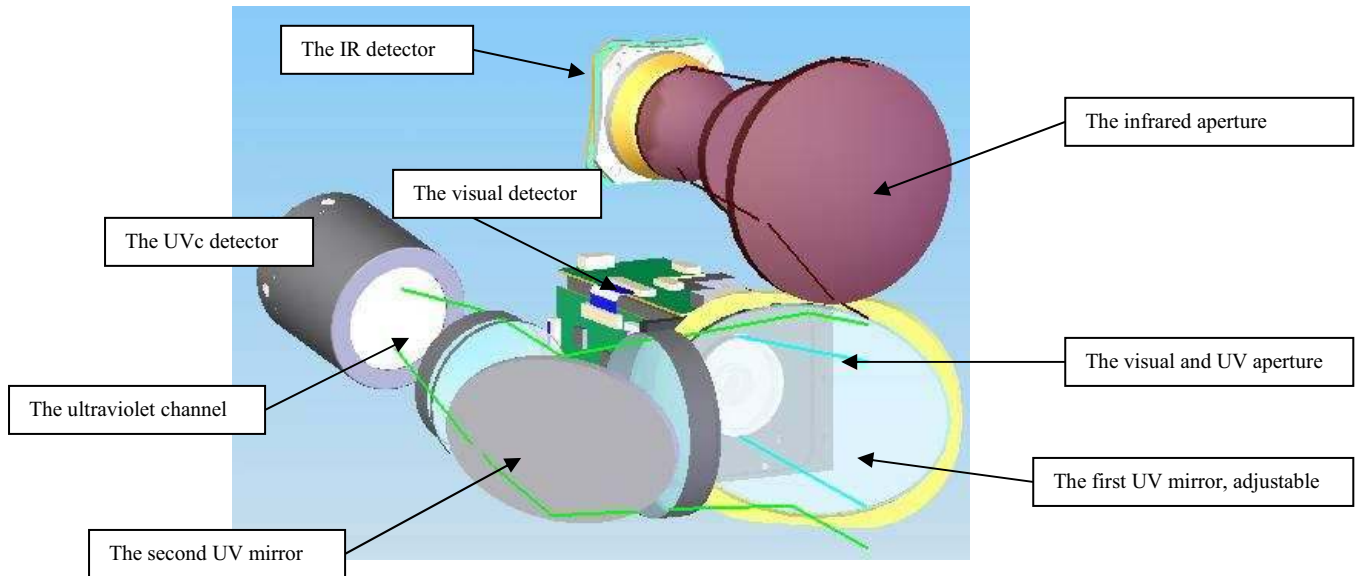
Figure 4: The opto-mechanical lay-out of the three channels

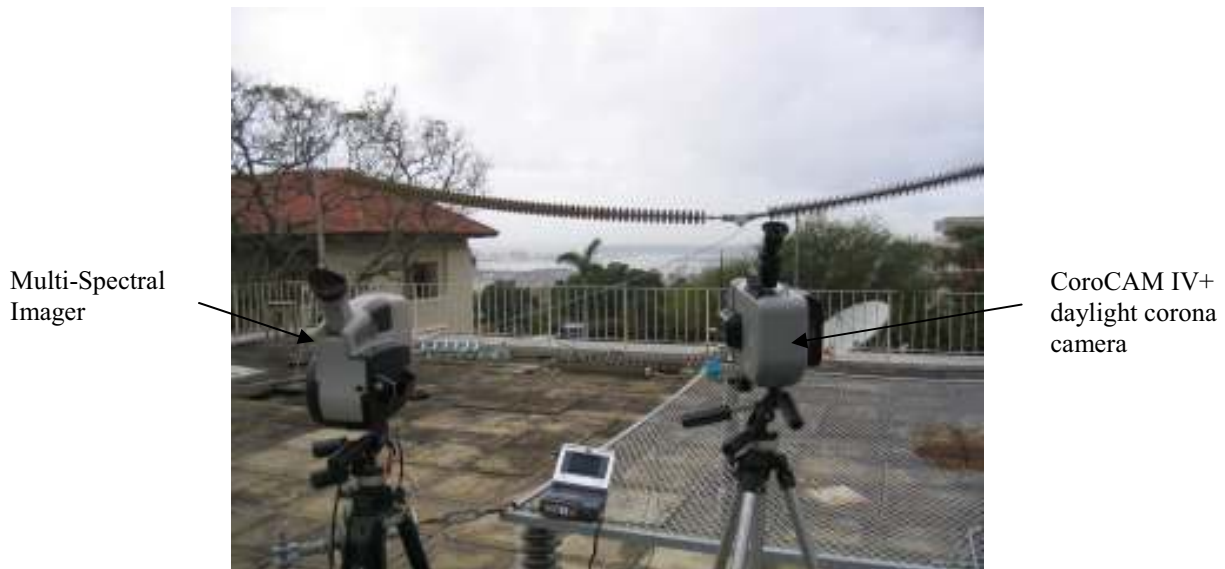
Figure 6 The Kwazulu Natal University test set up, on the left the Multi-spectral Imager, on the right the CoroCAM IV+ corona camera and in the background the suspended non ceramic insulator.

It was important that the evaluation be carried out under natural daylight conditions rather than in an indoor laboratory environment where the UV content produced by fluorescent and other lighting is expected to be well below natural daylight levels. [11] The experiment was conducted on the roof of the High Voltage Laboratory at the University of Kwa Zulu Natal, Howard College Campus where the insulator could be subjected to periods of high voltage stressing in an outdoor environment under both dry and wet conditions. The test arrangement is shown in Figure 6, and the insulator under test had visible damage along the sheath as shown in Figure 7. The insulator is rated at 400kV but for this work, there were two voltages applied to the insulator, namely, 120kV

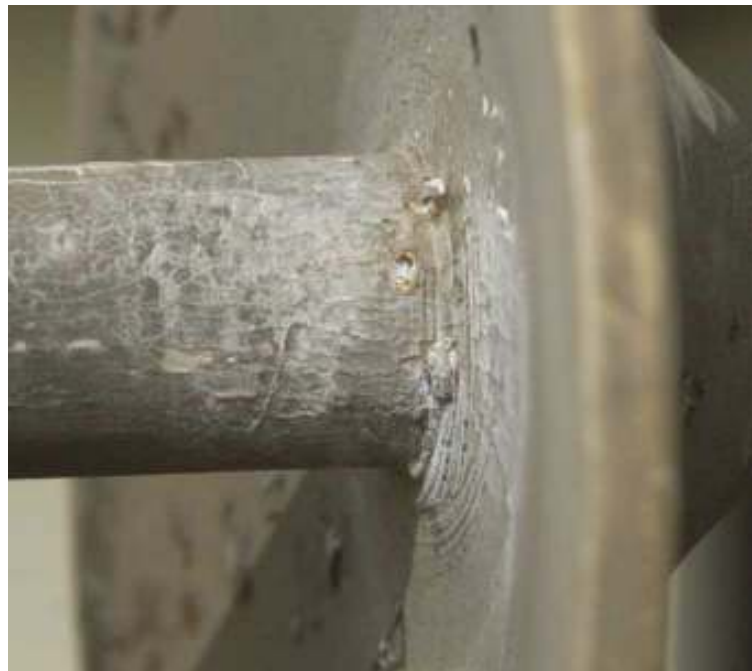
Figure 7: The visible damage of punctures along the sheath of the test insulator

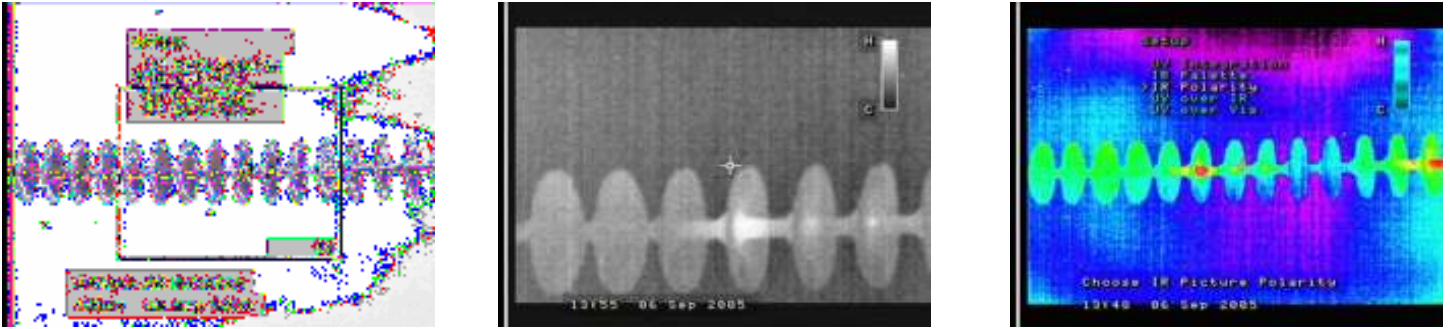
Figure 8: Ultraviolet, Infrared greyscale & iron bow images from the Multi-Spectral Imager under dry conditions at 120kV

From the outdoor laboratory evaluation we see that the Multi-Spectral Imager provides very good information relating to the existence and location of the corona and heat sources along the length of the insulator. We also see good correlation between the images in term of exact location as related to the actual damage. We note that the discharge activity increases when the insulator is wet, and also with the increase in voltage which can be expected.

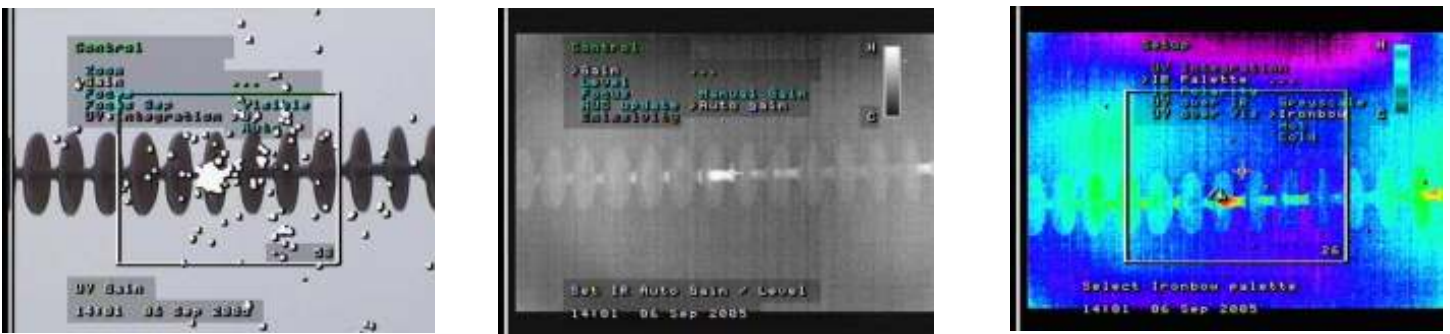
Figure 9: Ultraviolet, Infrared greyscale and UV overlaid on IR images under wet conditions at 120kV, note the increase in corona activities

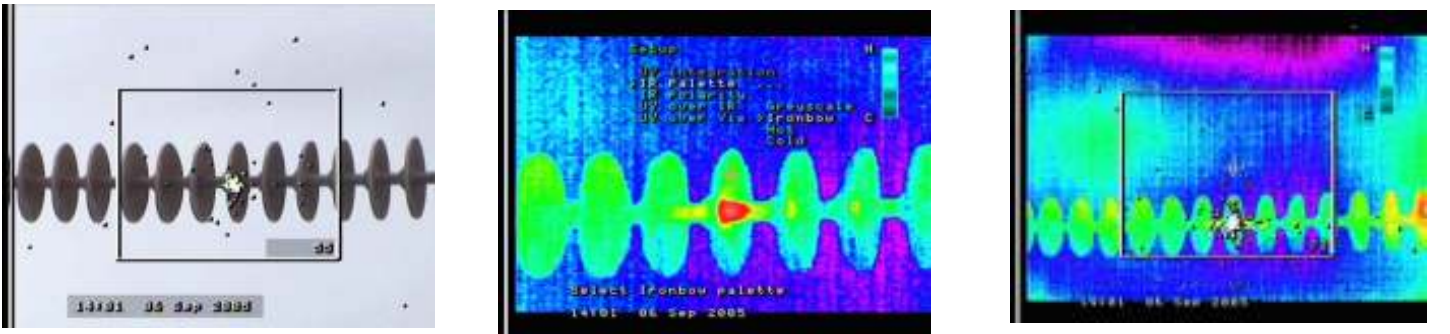
Figure 10: UV, IR iron bow and UV overlaid IR images under dry conditions at 160kV, note the increase in length of the hot spot

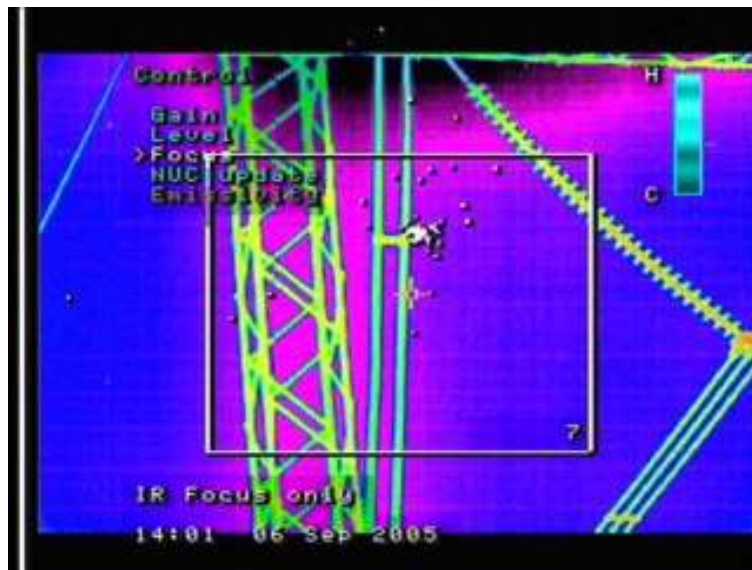
Figure 12: Infrared and overlaid UV image of a line spacer with discharge activities on its edges

The recordings in figures 14 to 16 prove that it is beneficial to scan substation equipment simultaneously with an infrared and ultraviolet imager as the UV- Visible-IR combination provides the user with the complete equipment performance picture. Furthermore, it is an advantage to have UV and IR images recorded in the same climatic conditions, at the same time and from the same point of observation as this will lead to a more reliable interpretation of the recordings.

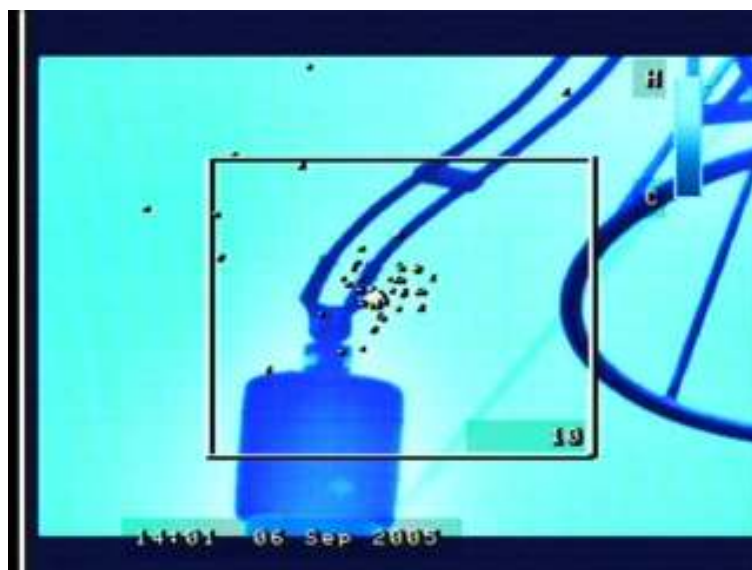
Figure 13: Infrared and overlaid UV image (cold colour palette) of

transformer bushing with corona activity on the conductor clamp

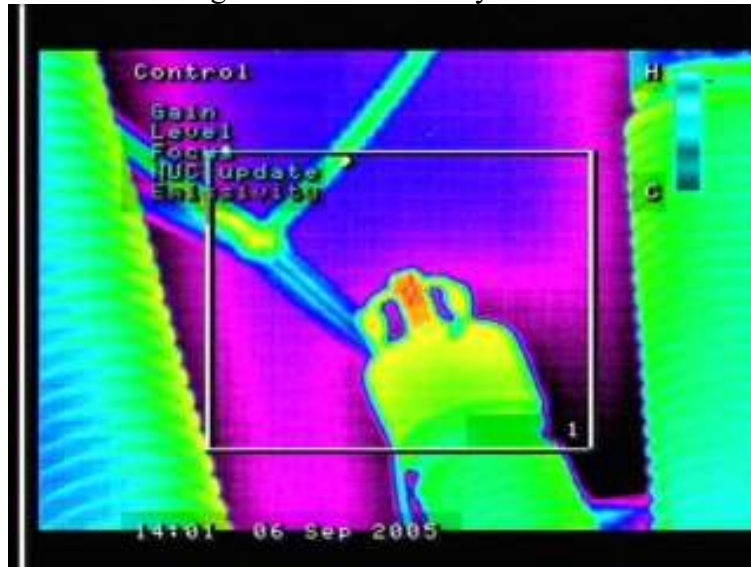
Figure 14: Infrared picture of transformer bushing, note: the top conductor clamp is slightly hotter than the cap
