WATER INDUCED DISCHARGES ON TRANSMISSION VOLTAGE SILICONE RUBBER INSULATORS

D.A. Hoch, N. Mahatho* and F. Bologna*

School of Electrical and Electronic Engineering
University of Natal
Durban, South Africa

*South African High Voltage Engineering Centre (SAHVEC)
TSI, Eskom Enterprises
South Africa

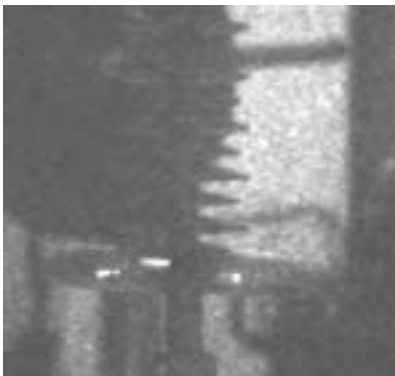
Figure 1 : Figure of dry insulator with corona ring fitted. No discernible corona activity. $V=173$ kV rms.

A 275 kV silicone rubber insulator was subjected to a.c. energization in the High Voltage Laboratory at the University of Natal. The unit under test was subjected to ac stressing at U_{max} under dry conditions and all corona modes recorded using a night vision image intensifier system. The unit was tested both with and without a corona ring fitted. The results are shown in Figure 1 and Figure 2 below.

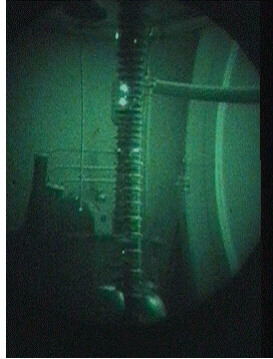
Figure 5 : Figure showing discharges along the length of the insulator for water droplets of conductivity 42 mS/cm. $V=173$ kV rms.

At higher conductivities, the water droplet discharges developed over time into more energetic activity and also occurred at points along the length of the insulator moving as a function of time from the vicinity of the live end towards the dead end of the insulator. In certain cases, discharges were observed on the sheath of insulator nearest the grounded end. This is shown in Figures 5 and 6 below.

The observed discharge modes of Figures 5,6,7 and 8 on the surface of the silicone rubber insulators clearly differ considerably to what is commonly referred to as water droplet corona. Of note is that the discharges may occur anywhere along the length of the insulator if the wetted insulator is subjected to ac stressing for a sufficiently long time. The appearance of corona near the dead end is a very surprising result as typical onset electric field values reported on in the literature for water droplet corona are 3.5kV/cm - 7.5 kV/cm [3]. The values of the electric field near the dead-end may be as low as 0.6 kV/cm . A typical electric field plot for the insulator tested and indicating electric field values of these magnitudes at the dead-end are shown in Figure 11 below.

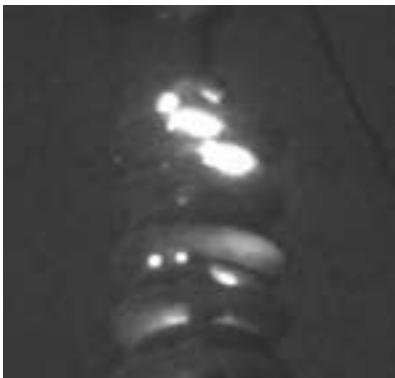
Figure 7 : Onset of discharge activity at dead end after ~30 minutes stressing. $V=173$ kV rms.

After some period of stressing (typically 20-30 minutes), a more intensive discharge mode was observed and which had the appearance of dry band activity observed under polluted conditions on glass cap-and-pin insulators. Such discharges are shown in Figure 7 and 8 below.

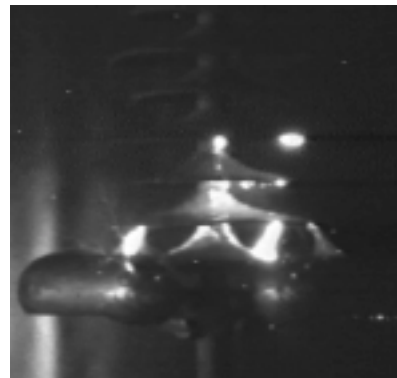
Figure 8 : Corresponding activity at live end. $V=173$ kV rms.
